CONSOL Energy Report

6/12/2014

MAWC Report

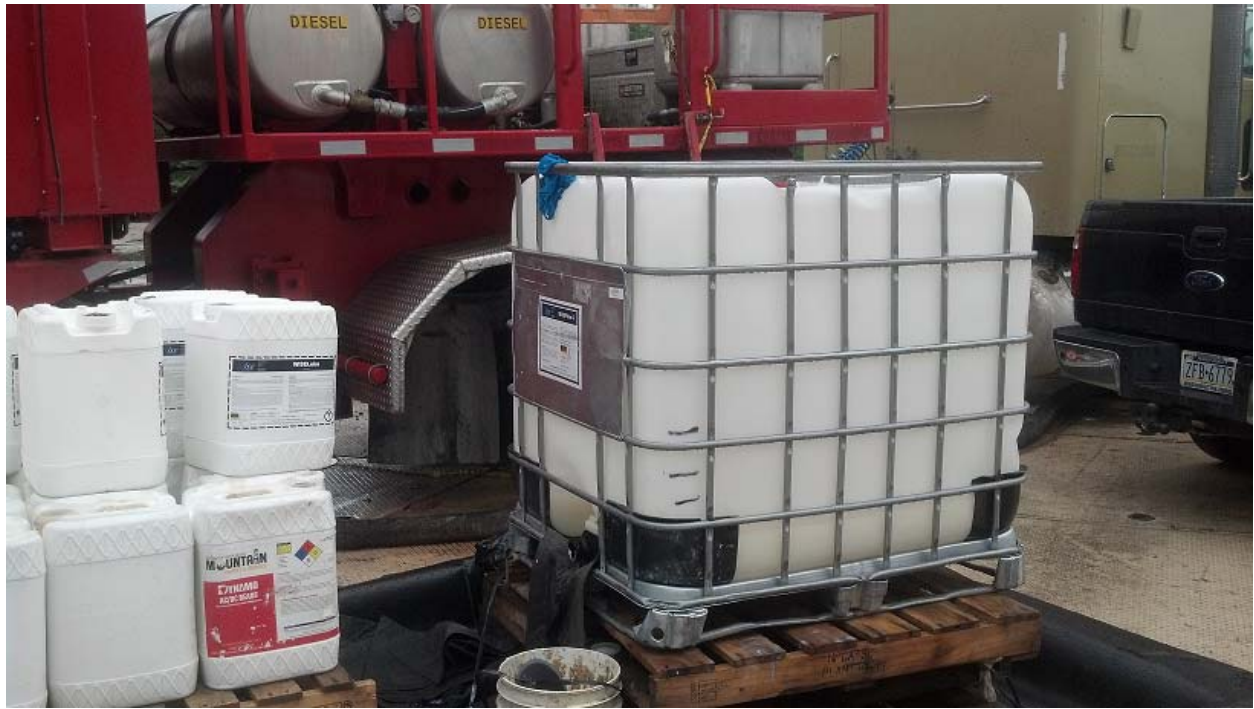
Pic# 1

On June 11, Consol had reported a cleanup of a drilling fluid spill from the previous evening. Original estimates of 50-100 gallons were revised to be approximately 5-10 gallons. The substance had accumulated over time through a process that involves loading the friction reducer from a tote (pic#1) into buckets and carrying it up a ladder to a tank to be pumped into the well (pics#2&5). Spillage from this process made it undetected to the main rubber liner for the entire pad (pic#3) and into a later discovered hole in the liner (pic#4). The cleanup consisted of removing this substance from above the liner and scraping off affected soil cement under the liner hole and hauling it to disposal. After cleanup a smaller secondary containment was placed under the tank on the truck (pic#6) to prevent spillage from contacting the main liner. No substance (WISEFlow-C) was detected in the drainage sump for the pad. The MSDS for this is on file.
