**Follow-up Air Quality Surveys at Beaver Run  
Reservoir near the Mamont Compressor Station  
and the vicinity of the Shaw Pad**

**Survey performed on 2/23/2019**

February 25, 2019

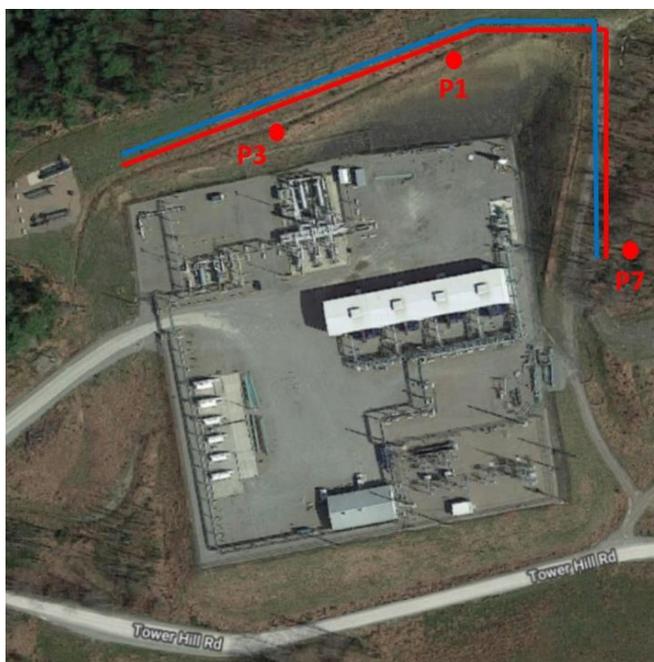
Figure 1. Aerial image of the Mamont compressor station. The red circles labeled P1, P2 and P7 mark the locations of carbon monoxide data logger placements. The red and blue lines show approximate paths of walking surveys for carbon monoxide and sulfur dioxide, respectively. The aerial image is from Google Maps.

At the Mamont compressor station, three follow-up surveys were taken. An Aeroqual Series 500 air quality monitor<sup>1</sup> was used to monitor carbon monoxide and sulfur dioxide concentrations in the air. In Figure 1, the points labeled P1, P3 and P7 mark the present locations of CO data loggers.<sup>2</sup> Point P7 is the closest to a compressor exhaust vent. A 15-minute spot logging for CO at point P7 was recorded. A walking survey recording CO concentrations was made along approximate pathway shown in red in Figure 1. As shown in Figure 1, the survey started at point P7, went to outside the northwest corner of the fencing around the compressor station and then back to P7. A walking survey for SO<sub>2</sub> followed the same approximate path and is shown in blue in Figure 1. The results of these surveys are reported in section 3.

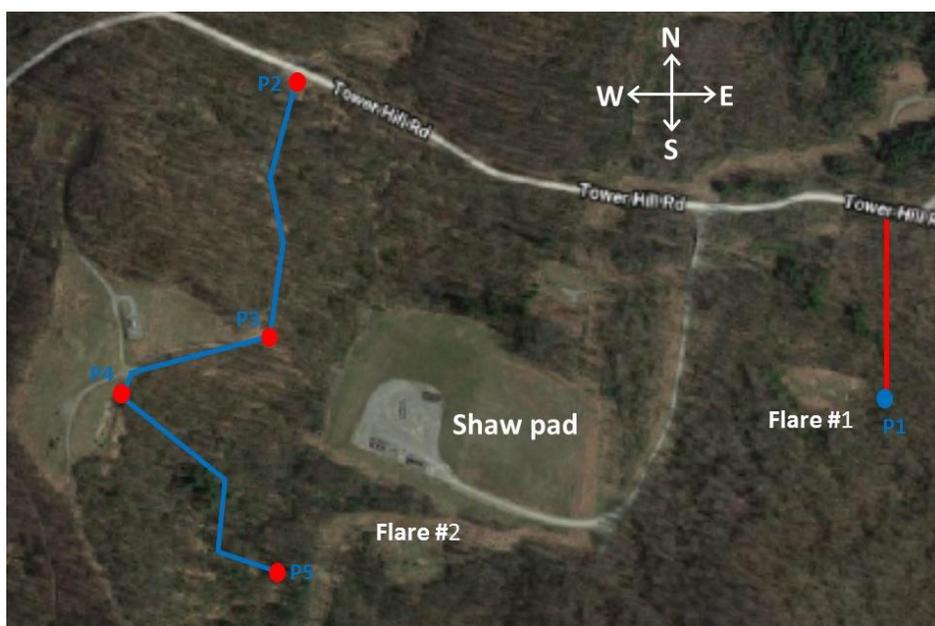
Figure 2. Aerial image of the Shaw pad and surroundings. Walking surveys for carbon monoxide and spot surveys of sulfur dioxide and were conducted on the red and blue paths (for CO) and at points P1 and P5 (for SO<sub>2</sub>). The aerial image is from Google Maps.

Walking surveys for CO and spot surveys for SO<sub>2</sub> were also conducted in the vicinity of the two flare sites near the Shaw pad. Figure 2 shows an aerial view of the Shaw pad and surroundings. Both flares were extinguished. On the day of these surveys both flaring stacks near the Shaw pad and the flaring stack off of route 380 were being dismantled. A walking survey for CO near the flare site east of the Shaw pad followed the approximate path shown in red in Figure 2. A spot survey for SO<sub>2</sub> near the point labeled P1-F1 was recorded. A second walking survey for CO followed the approximate path shown in blue in Figure 2 to the west of the Shaw pad. A spot survey for SO<sub>2</sub> was taken at the point P4-F2 to the west of the Shaw pad. The results of these surveys are reported in section 4.

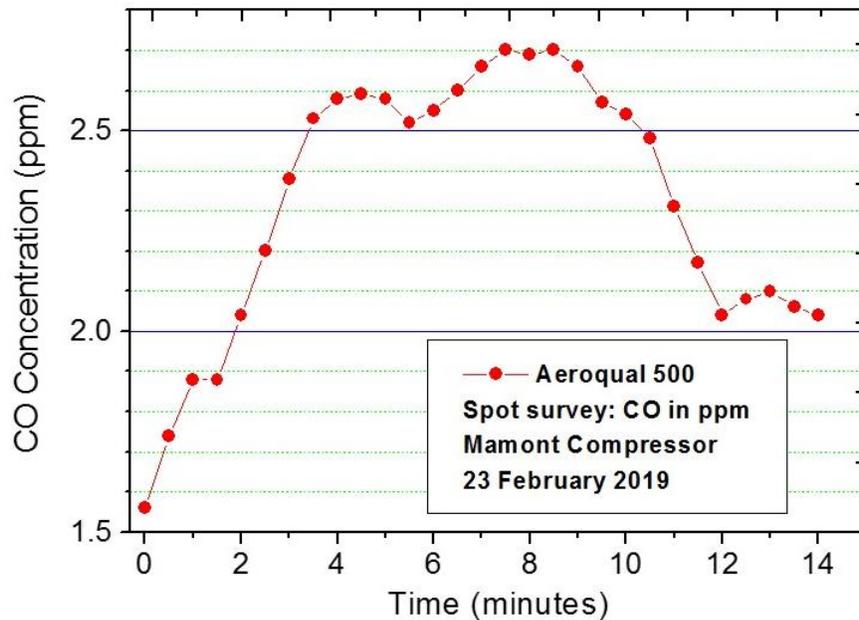
A spot survey for CO was taken near the point labelled P7 in Figure 1 starting at 12:20 pm on 23 February. The results are shown in Figure 3 below. The rising CO concentration signal during the first three minutes of the survey is due to the response time of the detector. The data shows that the CO signal concentration fluctuated between approximately 2.0 and 2.7 ppm.

Figure 3. Carbon Monoxide concentrations as recorded using the Aeroqual detector for the spot survey at the Mamont compressor on 23 February.

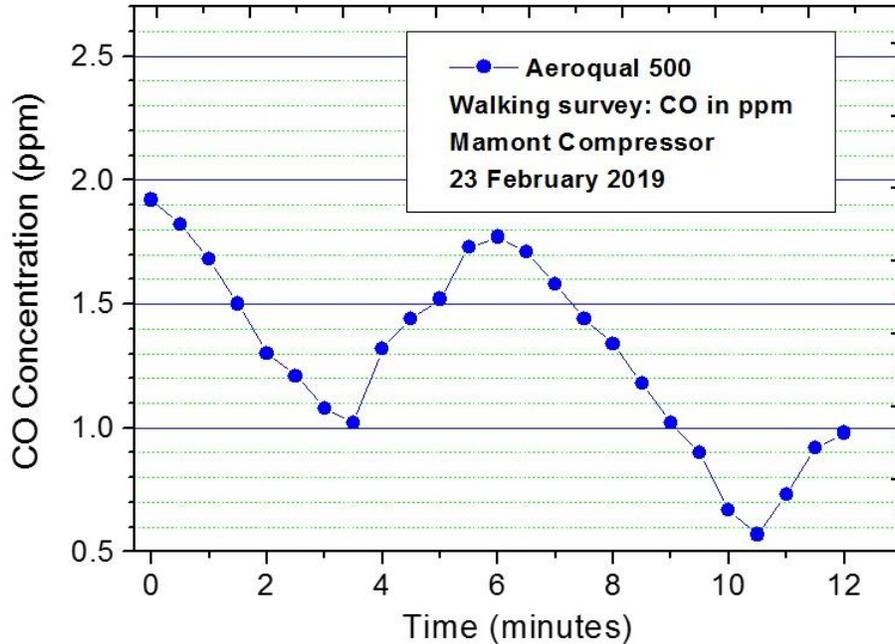
A walking survey for CO was taken starting at 12:36 pm on 23 February. The results are shown in Figure 4 below. The CO signal in Figure 4 starts near 1.9 ppm at point P7 in Figure 1. The minimum signal near 1.0 ppm at 3½ minutes corresponds to the top of the hill immediately north of the compressor in Figure 1. This is close to the point where the path walked turns left and proceeds along the ridgeline north of the compressor. The peak CO concentration near 1.8 ppm at 6 minutes corresponds to the point closest to the northwest edge of the compressor fencing at the upper left of Figure 1. The path walked then proceeded back to the starting point at P7 and ended there at 12 minutes.

It should be noted that the CO concentration (Figure 4) at any point on the walked pathway (Figure 1) should be interpreted as an approximate average value. The CO

concentration at any point should be expected to show a % fluctuation similar to that exhibited in Figure 3 recorded for the spot survey at point P7 in Figure 1. In other words, the peaks and valleys of the CO concentrations should not be associated with particular points along the walked pathway.

Figure 4. Carbon Monoxide concentrations as recorded using the Aeroqual detector for the walking survey at the Mamont compressor on 23 February.

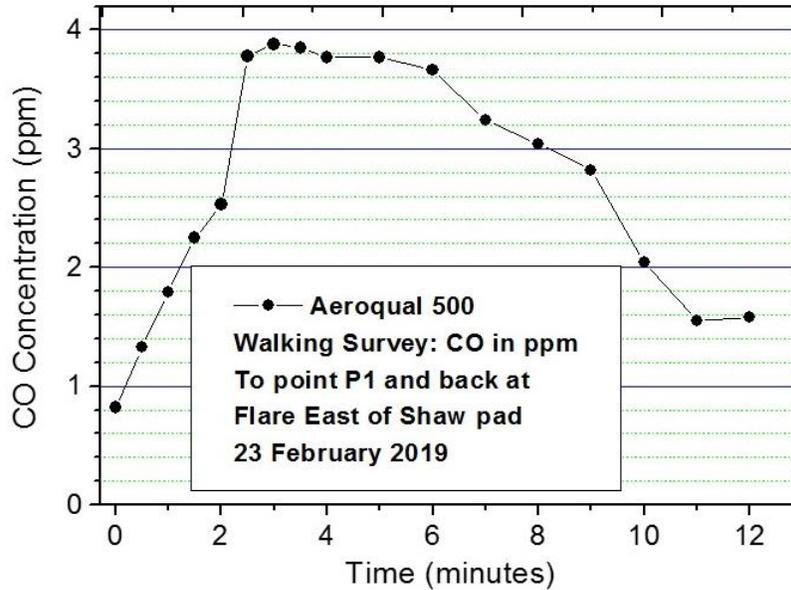
are shown in Figure 5 below. The rising CO concentration signal during the first 2½ minutes of the survey is due mainly to the response time of the detector. The maximum signals between 3.6 and 3.8 ppm were recorded on a narrow dirt road that is about 200 feet north of point P1 in Figure 2. The narrow dirt road is barely

Figure 5. Carbon Monoxide concentrations as recorded using the Aeroqual detector for the walking survey from Tower Hill Road to the point P1 directly east of the Flare #1 location and back to Tower Hill Road.

visible in Figure 2. The walked pathway arrived at P1 at the 8-minute mark and back at Tower Hill Road at the 12-minute mark.

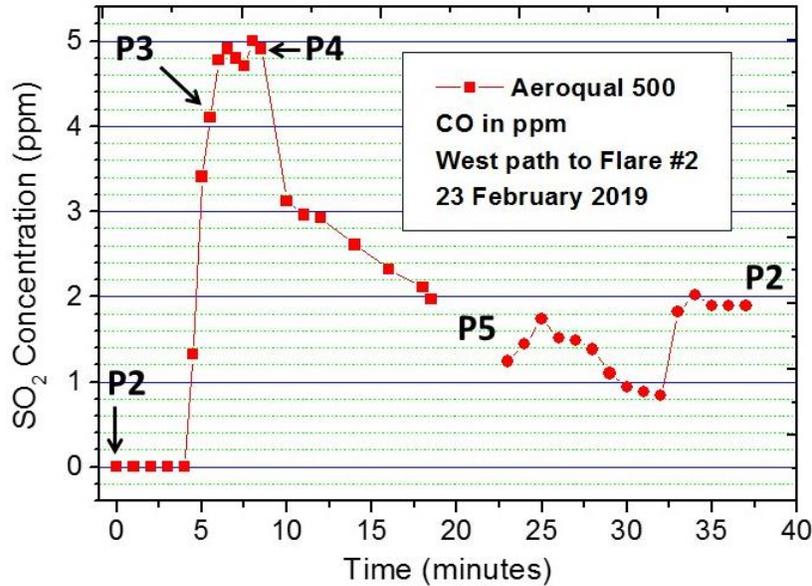
Figure 6. Carbon Monoxide concentrations as recorded using the Aeroqual monitor for the walking survey to flare #2 along the western pathway shown in blue in Figure 2. The labels P2 through P5 mark points on the pathway shown in Figure 2 and the corresponding recorded CO concentrations.

After the spot SO<sub>2</sub> survey, the CO detector was switched back into the Aeroqual monitor and the CO concentration monitored throughout the walk back through the woods to point P4, then down the dirt roadway back to point P2 at the 37-minute mark.

The overall trends shown in Figure 6 show a remarkable similarity to trends along the walking survey along the same path of 10 February. In particular, both surveys show a rising CO concentration along the uphill dirt roadway from P2 to P3 and P4 and then a decreasing CO concentration as the path walked goes downhill through the woods to point P5.

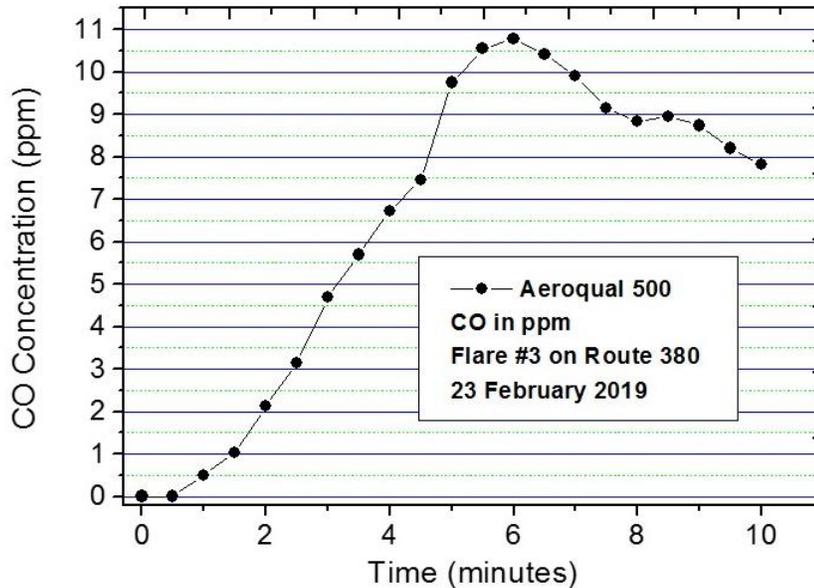
CO was monitored at the flare site just off route 380 about 2480 feet west of Beaver Run Road. The flare stack was observed as being dismantled at 11:00 am when driving to the Mamont compressor site. The stack was entirely removed by 2:56 pm when the spot survey next to this site was conducted. The results are shown in Figure 7 below. An average concentration of about 7 ppm was observed over a 10-minute scan. Again, the rising concentration from 0.0 ppm to 4.7 ppm over the first 3 minutes of the scan

Figure 7. Carbon Monoxide concentrations as recorded using the Aeroqual monitor for flare #3 just off Route 380 on 23 February.

represents the response time of the detector adjusting to the average concentration at the monitor.
